**APPENDIX A:
PRELIMINARY TREE EVALUATION**

June 3, 2015

Site: Coastside Fire Station #41, El Granada, CA

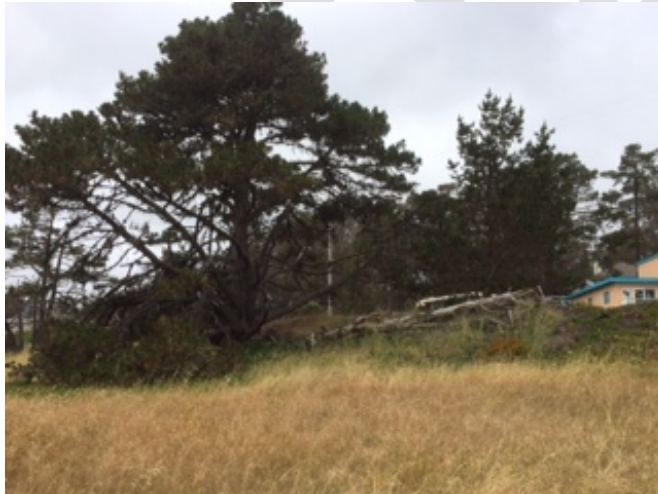
Tree #1 with a large failed leader at the base.

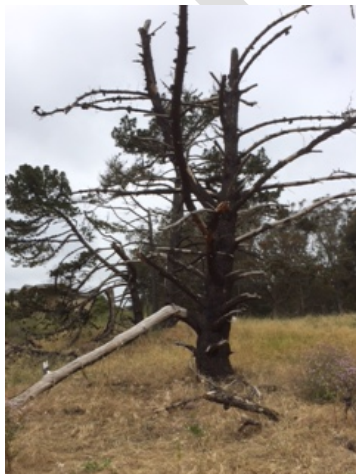
The trees on site are a mix of imported trees, there are no trees native to the El Granada area. The Monterey pines on site are in decline. The trees have a history of large limb and leader failure. Bark beetle has infested the trees and the trees will soon be dead. Pine tree #4 has already dead and the remaining will follow. Remove the Monterey pines prior to construction and replace as required with appropriate trees for the fire station. Natives are highly recommended.

Dead Monterey pine #4. Bark beetle and pine pitch canker has contributed to the death of this tree.

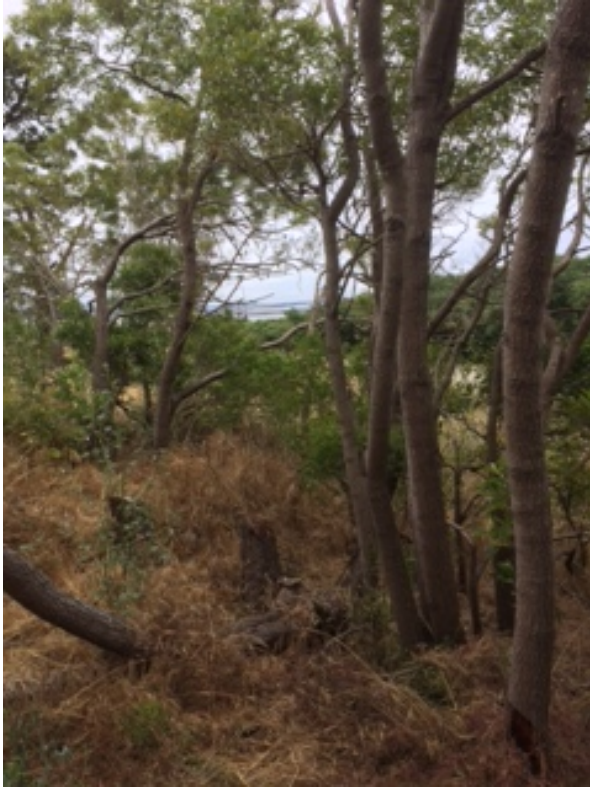
The acacias and the eucalyptus are of an invasive species that are known to be flammable. Remove these invasive trees and replace with appropriate trees at the time of landscaping. If any trees are retained the following tree protection plan should be followed. Tree protection will lessen impacts to retained trees and the riparian area.

Grove of acacias, the photo depicts the invasive nature of the species.
